Performance Evaluation of the Tanoso Irrigation Scheme in the Brong -Ahafo Region of Ghana

***Shaibu Abdul-Ganiyu, Benneh Kobi Agyeman and Thomas Apusiga Adongo**

Abstract - *The purpose of the study was to assess the performance of the Tanoso irrigation scheme in terms of distribution uniformity, coefficient of uniformity, water application rate/efficiency, infiltration rate and storage efficiency of the soil. The study was done in Tanoso irrigation scheme where data was obtained through primary and secondary sources between March and April, 2016. Primary data was obtained from interviews, field measurements and field tests while secondary data were obtained through literature review. The data obtained were analysed using efficiency equations and Microsoft Excel. The scheme had an average infiltration rate of 10.32mm/h and an average application rate of 10.13mm/h which indicated that, there is rapid drainage of water in the soil and deep percolation. The distribution uniformity values calculated for both lateral 1 and lateral 2 were 74.04% and 79.7% respectively which indicated that they were all performing according to recommended value of 70% or higher for rotor sprinkler irri

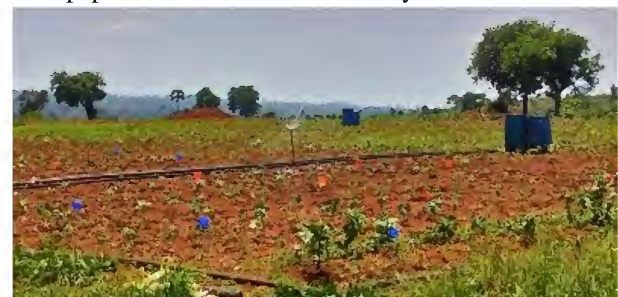
Plate 4: Catch Can (Pink colour) Arrangement on the field

Field observation and measurements were employed in the gathering of primary data. Catch can test was conducted to measure the uniformity coefficient and distribution uniformity. Thirty (30) catch cans were used for the data collection. Each catch can had a diameter of 120 mm and a height of 115 mm. The cans were arranged on a square grid having a spacing of 3 m x 3 m. The catch cans covered an area of 16 m x 15 m between two sprinklers near the pressure head. Before the experiment was conducted, the pressure head of the sprinkler was measured at a specified pressure and the test was to capture water falling at both sides of the cans arranged along the laterals. The cans were checked and emptied of water before the test was conducted; the sprinkler was made to rotate to collect water into the catch can for a period of time. The experiment was conducted at two locations, lateral 1 (up -stream) and lateral 2 (down -stream). Each test lasted for duration of one hour. After an hour of the experiment, twenty-eight (28) out of the thirty (30) cans received water from the up-stream, and all the thirty (30) catch cans received water from the down-stream, however, care was taken to check overflow of the water in the catch cans. The source of secondary data included reviewing books, articles and newspapers which relates to the study.

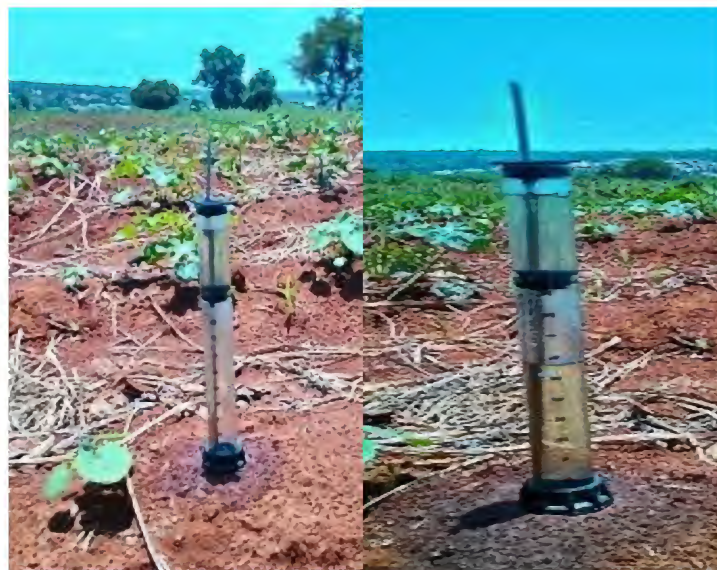
Plate 5: Infiltration Test on the Irrigable Area Using Mini-disk Infiltrrometer

The average application rate was determined using a container of volume 1.5 litres to estimate the discharge from two sprinklers. The average discharge was calculated to be 40.54L/min. The application rate was also determined to be 10.13mm/h. Infiltration test was conducted along three laterals (up-stream, middle stream, down- stream) to determine the average infiltration rate of the soil. The application rate was calculated to

be 10.13mm/h, while the average infiltration rate of the soil was 10.32mm/h. Infiltration rate determines the rate at which water moves vertically down into the soil and the potential for runoff. From the analysis, the average application rate of 10.13mm/h was less than infiltration rate, which causes deep percolation and rapid drainage of water. It shows that all the water applied during irrigation is infiltrated into the soil. This implies that, the field is receives less water than required.

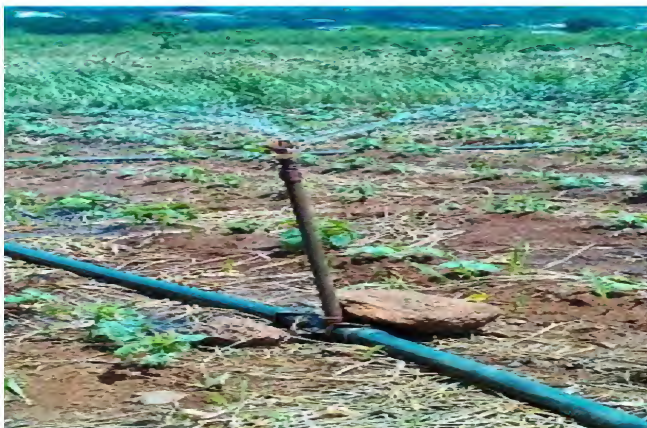
Leakages from pipes, main lines, broken weir, dam gates blockage by weeds, riser mal-function, were also another challenge for quality water conveyance to the field causing runoff and soil erosion. According to the farmers, there were not much pipe lines and sprinkler riser. This made it difficult to convey water to the upper parts of the field and distant farm site were unable to undergo irrigation due to these challenges. All these challenges tend to affect the distribution uniformity of the sprinkler in the scheme.

Plate : Malfunction Riser and Leakages from Pipes

- Employment of permanent engineers and skilled personnel,
- MeasureS should be put in place to ensure payment of irrigation service charge for regular repairs and maintenance,
- There should be proper supervision of the irrigation scheme,
- Frequent performance evaluation and monitoring should be carried, and
- Supply of adequate sprinkler irrigation equipment and repair all malfunctioning equipment.

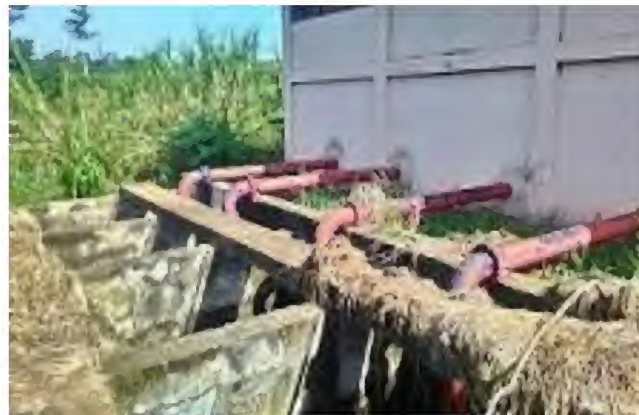
Plate: Blockage of Weeds at Water Suction Point
